Manhole Inspection Summary

Manhole # S15QQ1021MH

Location Address: **4925 LANIER AVE**

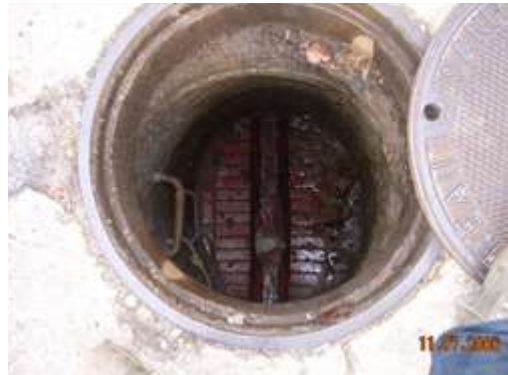
Top View

Corroded steps. Evidence of surcharge - Bench debris.

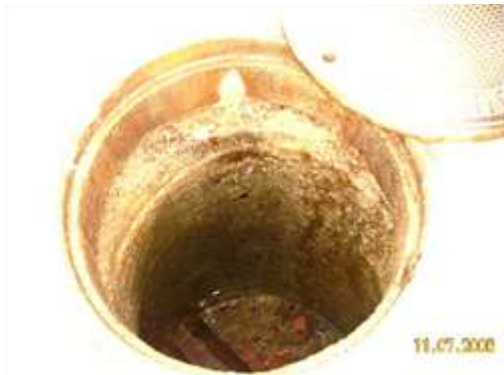
Defect

Frame leaks. Frame offset. Corbel deterioration and infiltration. Barrel infiltration.

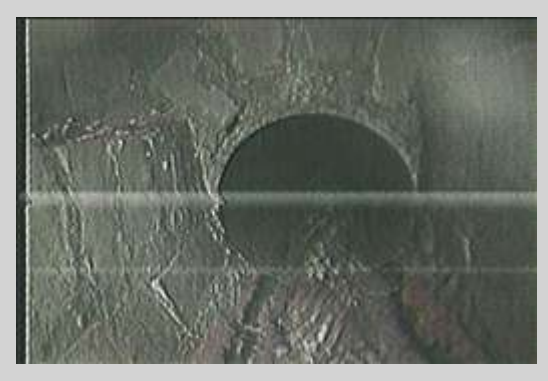
8 in. Circular Gravity Sewer Pipe Out @ 12 O'Clock

Channel deterioration.

Infiltration: **None** Pipe Seal Cond: **Cracked**

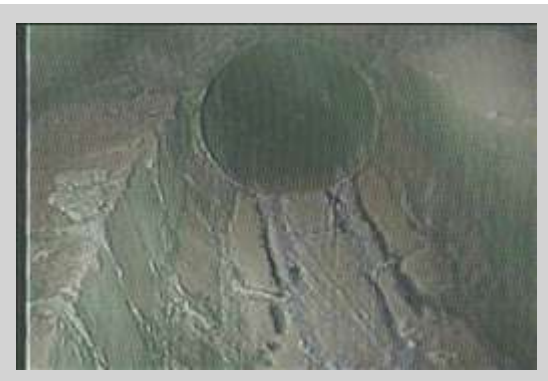
8 in. Circular Gravity Sewer Pipe In @ 6 O'Clock

Infiltration: **Evidence** Pipe Seal Cond: **Cracked**
